## YIKU TLT Axial Fan Impeller Parts Supply Fan Blade Handle M45\*1.5 118\*341mm

Blade Shank, Supply fan blade handle M45\*1.5,  $\phi 118 \times 341$

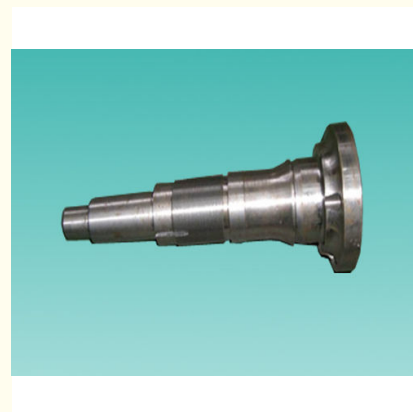
- Name: Blader Shank
- Model: S2GA2182
- Material: 42CrMo-5
- Quantity: 1
- Purpose: Connecting Carriers
- Applicable To: Blower
- Highlight: fan blade handle M45, fan blade handle 341mm
